**Flood Control Project Maintenance
Levee Inspections**

Maintenance Issue Types Only, Levee Inspection Report By Mile - Spring 2020

Reclamation District No. 0001 Union Island

Waterway	Bank	Unit Miles	Inspection Start/End	Inspector
Unit No. 01 Old River	Right	1.14	03/10/2020 03/10/2020	Alberto De Leon

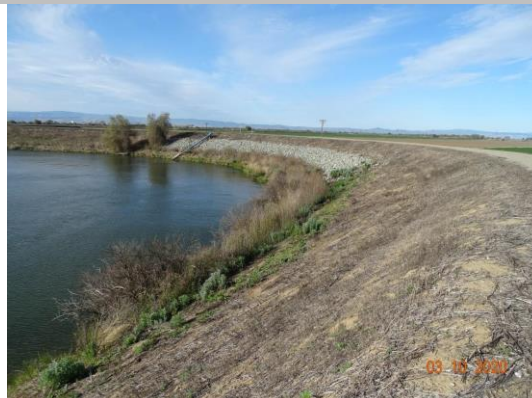
Photo 1 of 1 : SP_2020_RD0001_23_11_20200318_00014.jpg

LM Start	0.31	Rating **	M	Issue No.	11
LM End	0.33	Issue Type +	Ma	Location *	WS
Category	Earthen Levee			GPS Latitude/Longitude	
				Start	End
Item	Erosion / Bank Caving			37.820300 °	37.820200 °
				-121.379500 °	-121.379800 °
DWR ID	LMA-402				
Comment Code					
E2 : Schedule repair of erosion site prior to the next inspection.					
Inspector Comment					
2017 Storm Damage site					
ID NO. 496					
LMA-402					
Slope protection repairs are needed along the waterside slope. Minor toe erosion has displaced riprap.

View of waterside slope looking downstream. Spring 2020

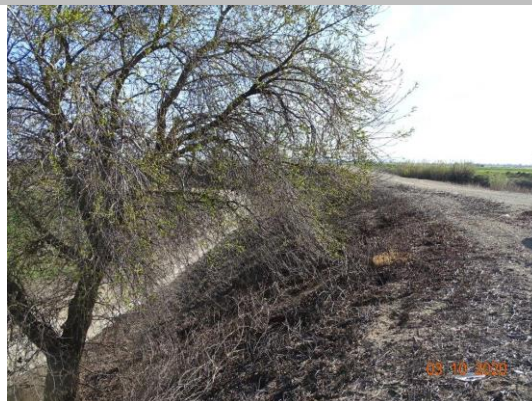
Photo 1 of 2 : SP_2020_RD0001_23_19_20200318_00015.jpg

LM Start	1.13	Rating **	M	Issue No.	19
LM End	1.13	Issue Type +	Ma	Location *	LS
Category	Earthen Levee			GPS Latitude/Longitude	
				Start	End
Item	Trim / Thin Trees			37.811714 °	37.811714 °
				-121.384876 °	-121.384876 °
DWR ID	DWR_RD0001_01_s_2018_19				
Comment Code					
T1 : Trim trees to at least five feet above ground level.					
Inspector Comment

View of tree branches on landside slope that need to be trimmed at least 5 ft. above ground. Spring 2020

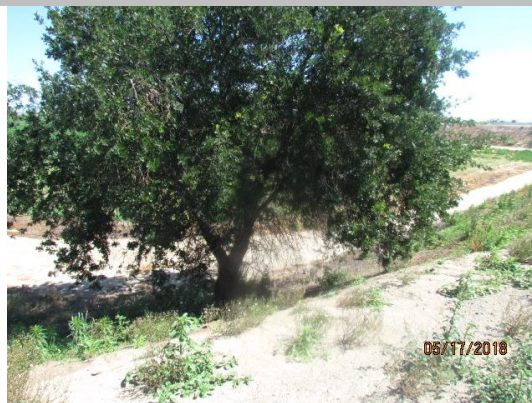
Photo 2 of 2 : SP_2020_RD0001_23_19_20200228_00005.jpg

Looking west at untrimmed tree at landward toe. (Spring 2018)
